WHY BUILDINGS FALL DOWN

How Structures Fail

MATTHYS LEVY
and
MARIO SALVADORI

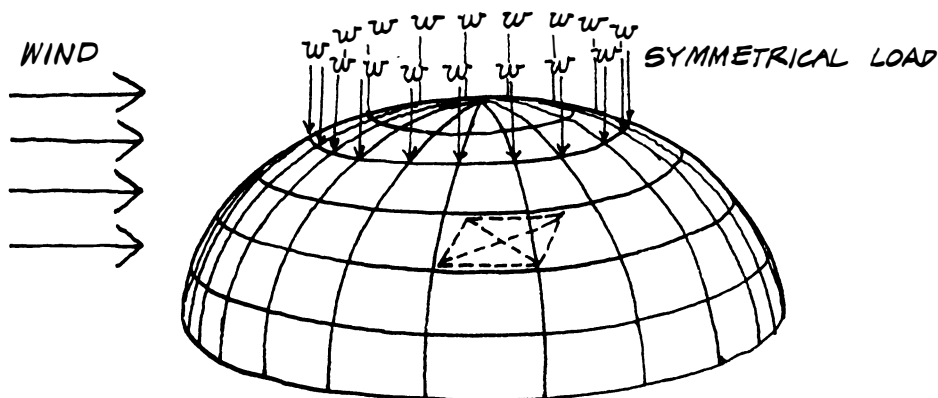
3.14 Skewing of Radial Ribs Caused by Wind

But perhaps the most dangerous consequence of using membrane theory in the design of shallow reticulated domes is that under symmetrical gravity loads its meshes *shrink* (slightly) on all four sides, *remaining square*, while under wind loads they become skewed (Fig. 3.14) and require diagonals to be stable. Finally, since most of the bars of the mesh are compressed, reticulated domes must be checked against the dangerous phenomenon of *instability in buckling as a whole*, which causes the dome to invert or *snap through*. (You may easily check instability in buckling by pushing down on a thin metal or plastic ruler that will bend out at right angles to its thin surface and lose all capacity to resist compression higher than a small push [p. 289, Fig. D4].) Rather unwisely the

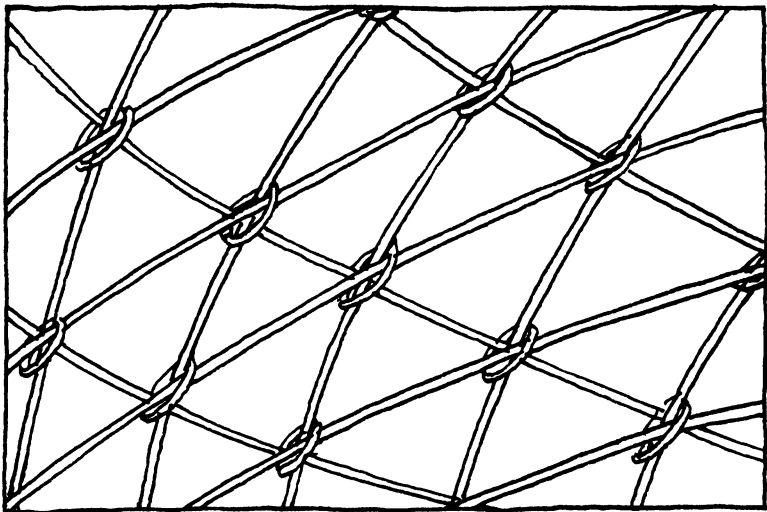
3.16a Bar Arrangement in Bucharest Dome

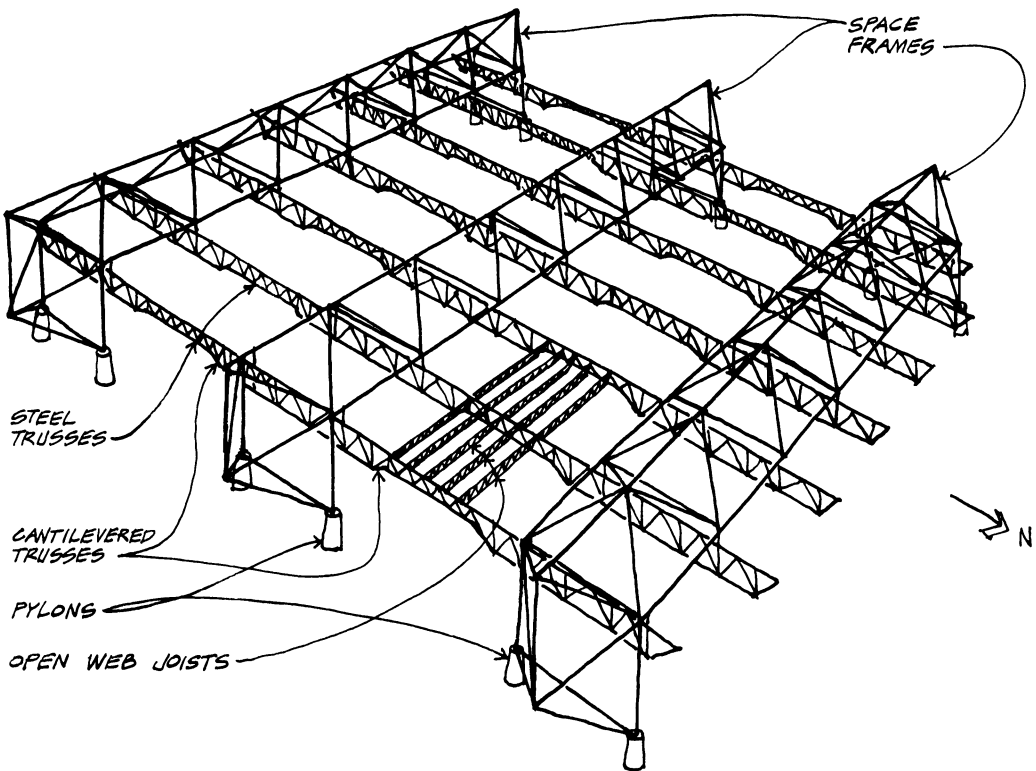
4.4 Diagrammatic Layout of Structure of the Kemper Arena

The basic structural elements supporting the loads of the roof itself and those acting on it, as well as the weight of the upper part of the walls of the arena, were three external space frames spaced at 153 ft. (46 m) in the north-south direction in the shape of rectangular portals, 360 ft. (108m) long in the east-west direction, and 81 ft. (24 m) high (Fig. 4.4). The horizontal element, or beam, of the portals consisted of a *space frame* of steel tubes with an equilateral

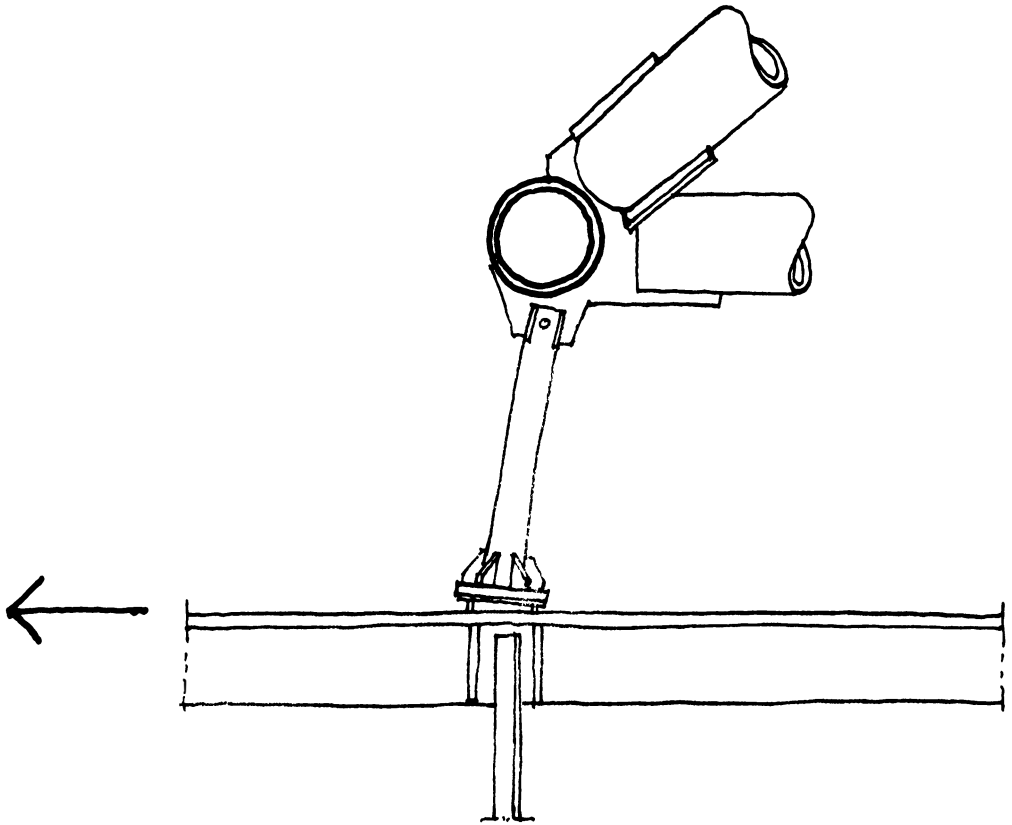
4.7 Hanger Assembly: bent by Lateral Force

another 1,500 tons), then each of the forty-two hangers was to support in *tension* 140,000 lb. (622 kN). Moreover, they had to resist the horizontal, variable wind forces (exerted on the roof and on the upper part of the walls hanging from it), which tended to move the roof horizontally as a gigantic pendulum. For this purpose six of the hangers were hinged both at their top and about halfway down their length, while the remaining thirty-six were hinged only at the top and connected (almost) rigidly to the top chord of the large trusses. While the two-hinge hangers allowed the roof to move as a pendulum, the single-hinge hangers limited the horizontal roof motions to the *bending* deflections of these hangers (Fig. 4.7).

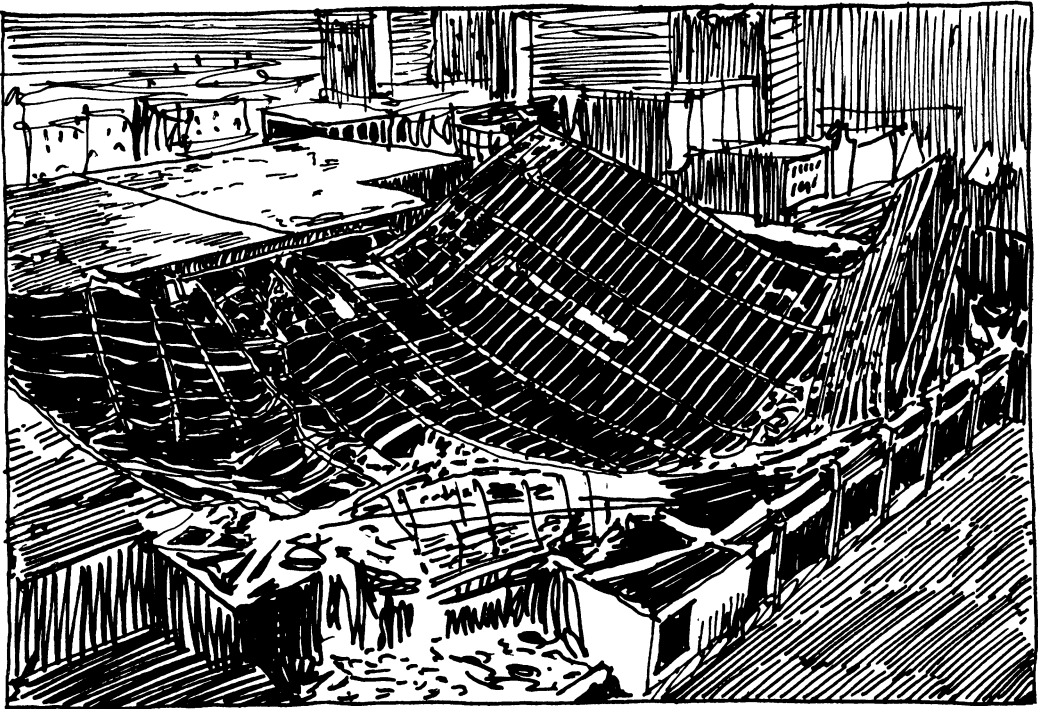
4.10 Hartford Center Roof: after the Collapse

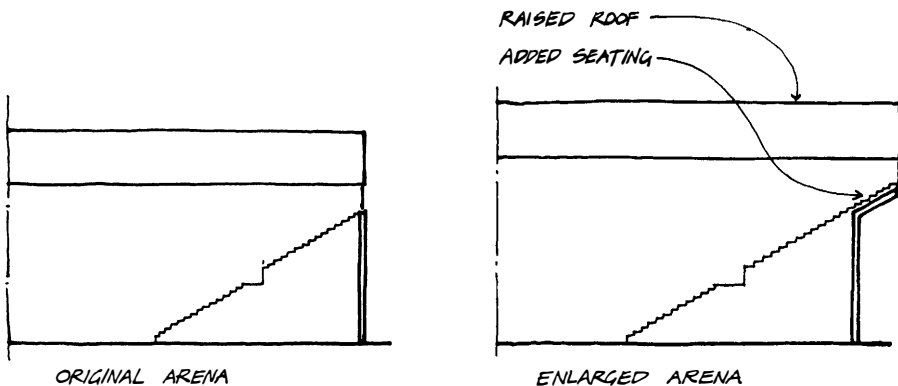
4.15 Section through Original and Enlarged Arena

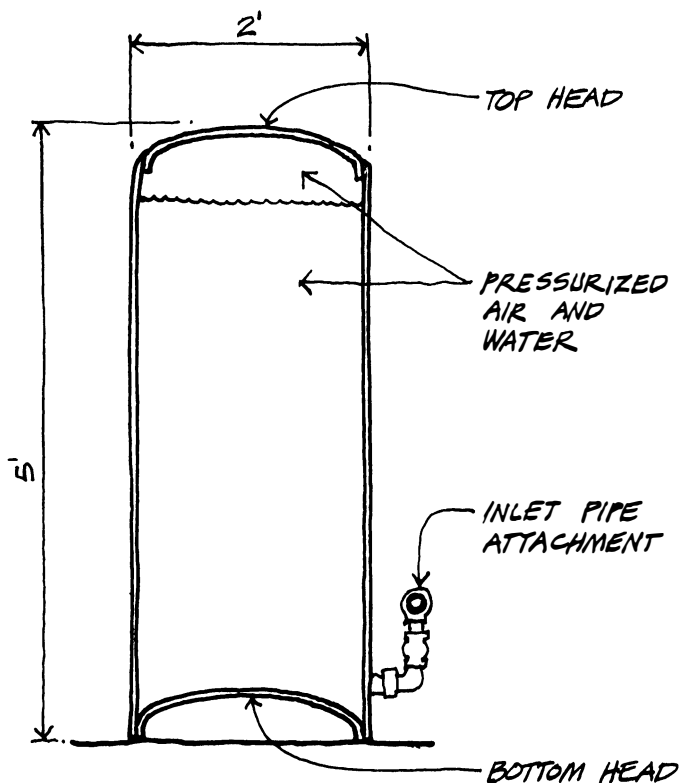
5.5 Hydropneumatic Tank

Very early on the morning of the blast an employee of the photo lab went to the basement and closed the safety switch on Tank No. 2, instantly starting the pump, but when he returned to the lab on the sixth floor, he noticed that the pressure gauge there showed almost no pressure in the system. He went right back to the basement to check the problem and found Tank No. 2 lying on its side on the floor and water flooding the area from a broken pipe that had been connected to the tank. He also smelled gas. He left immediately to call for help, but before he could reach the lobby, a powerful explosion engulfed him in dust and flying debris.

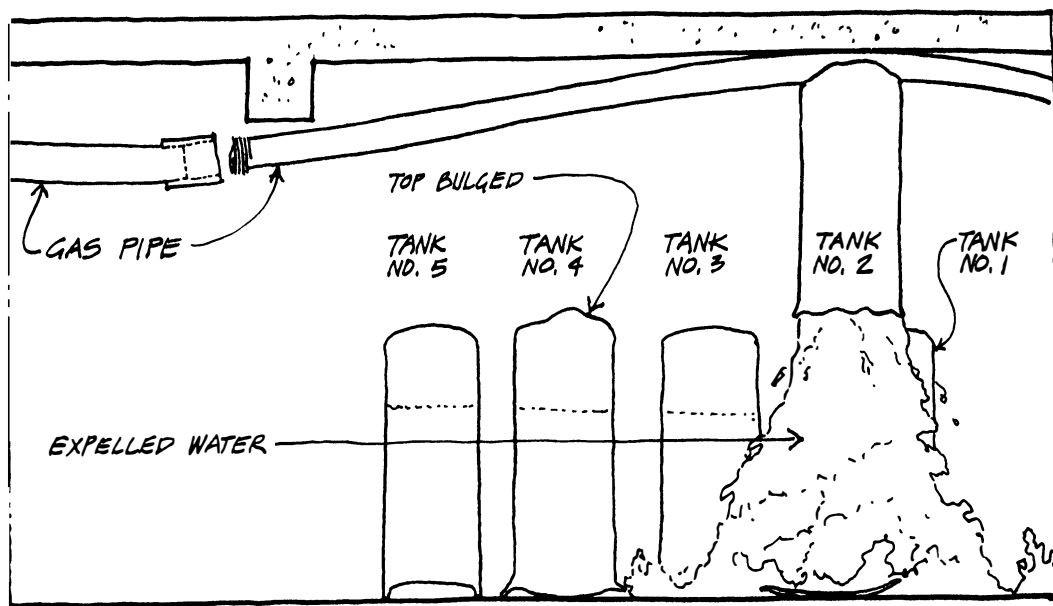
5.6 Ruptured Tank Striking the Gas Pipe

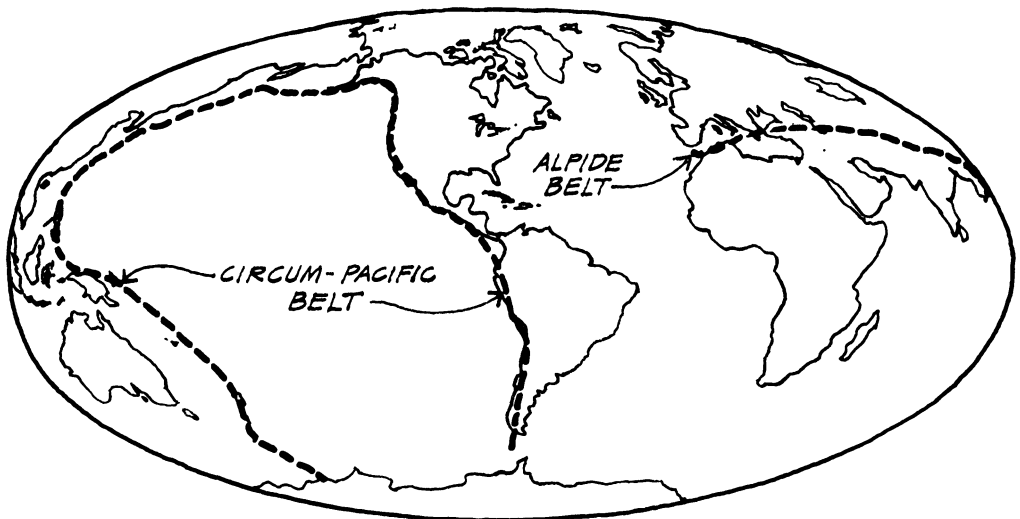
6.1 World Seismic Bands

The earth's crust is like a broken eggshell floating on the viscous inner magma of melted rock. Plate tectonics, the recently developed theory of movements of the earth's crust, offers the most plausible explanation for the existence of bands all over the globe along which most earthquakes occur. These bands contain *fault lines* or cracks that are, in fact, the edges of the tectonic plates and, as correctly observed by Strabo, occur primarily along continental coasts (Fig. 6.1). These giant plates move relative to one another

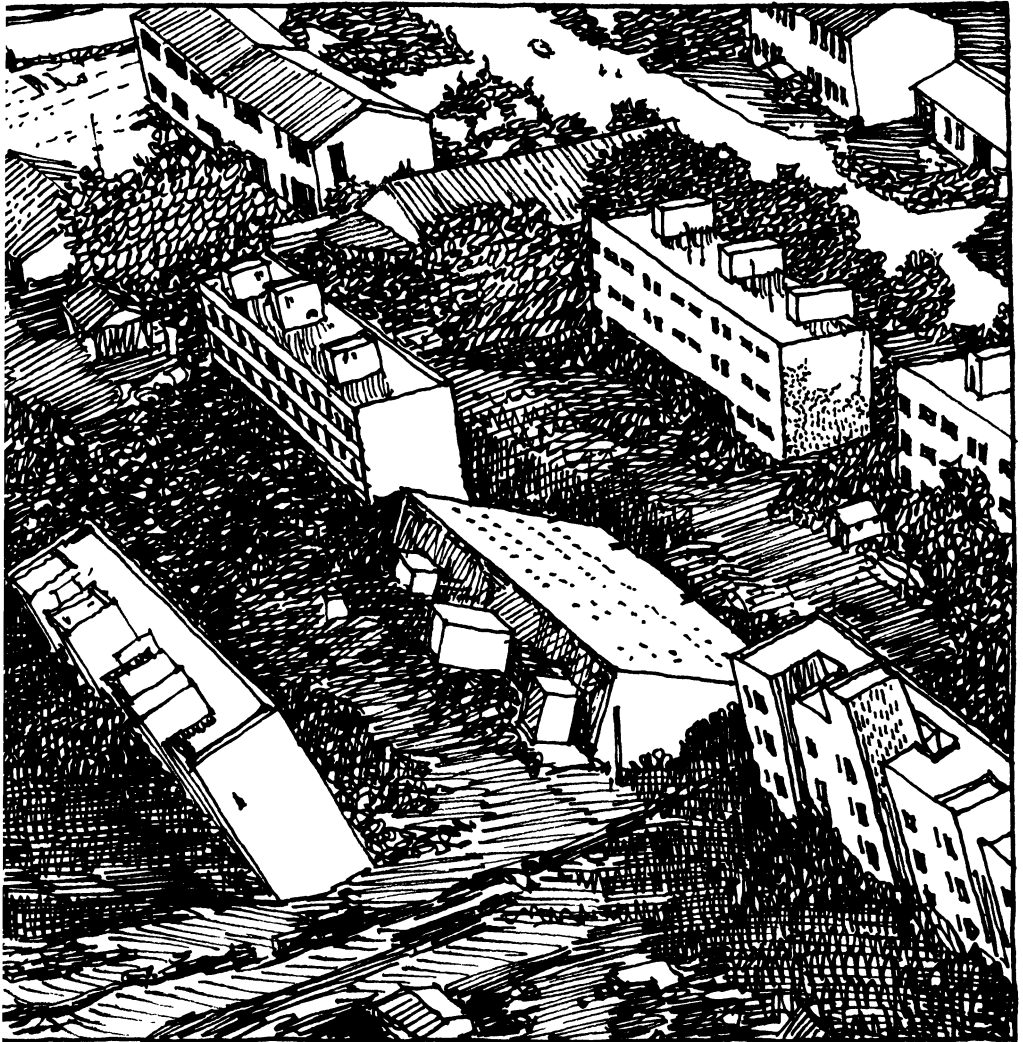
6.6 Niigata Apartment Buildings: After the Earthquake

urated with water that suddenly become liquid when subjected to shaking from the quake. To demonstrate this action, place a weight on a pot full of sand to which water has been added almost to the top. Shaking the pot will cause the sand-water mixture to liquefy and the weight to sink and/or tilt. This is precisely what happened in Niigata, Japan, in 1964, when an apartment building tilted through an angle of 80° from the vertical without breaking up, so that after the movements stopped, the occupants were able to walk to safety down the face of the building (Fig. 6.6).

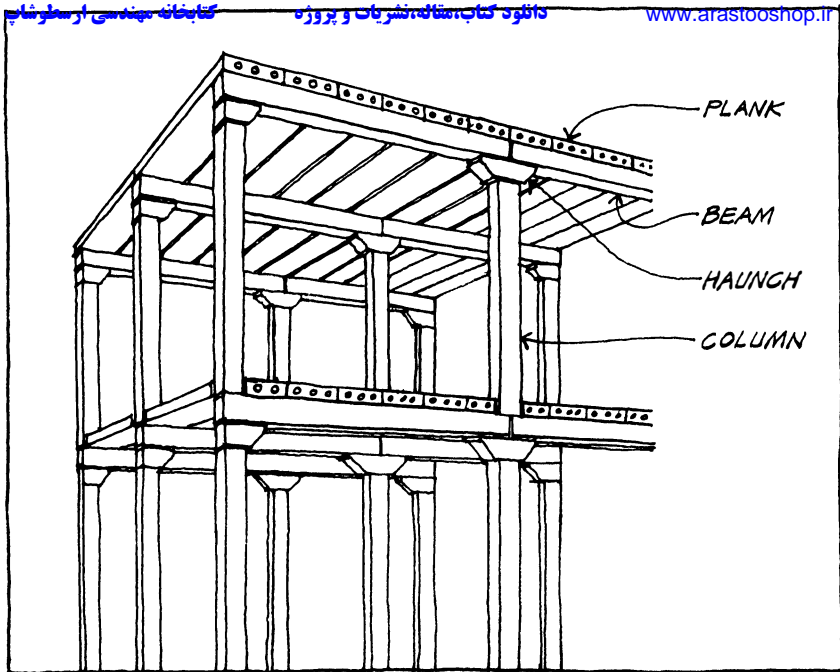
6.7 Precast Concrete Frame Construction

The earthquake of December 7, 1988, near Spitak, Armenia, with a magnitude of 6.8, had a duration of strong motion of only ten seconds but was devastating, causing the deaths of more than twenty-five thousand people, most of them trapped in schools, apartment buildings, and public buildings. Of the three cities damaged by the shock, Leninakan, located farthest from the shock (20 miles [32 km]), was more severely damaged than Kirovakan, 16 miles (25 km) from the rupture zone. Leninakan lies in a broad alluvial plain and is underlain by deep sedimentary formations in what may have been an ancient lake. Kirovakan has a thin soil layer above a rocky base. The softer soils in Leninakan magnified the intensity of the shock and resulted in over 50 percent of the structures collapsing or having to be demolished. The most vulnerable structures turned out to be those consisting of precast concrete columns and beams joined to create frames nine to twelve stories high. Precast hollow-core concrete slabs spanned between these frames to create floors (Fig. 6.7). Almost all these housing blocks (there were 133 in Leninakan) collapsed or were so seriously damaged as to be unsafe and had to be demolished. An examination of the debris revealed that all the joints in the precast construction were weak; there was no connection between adjacent

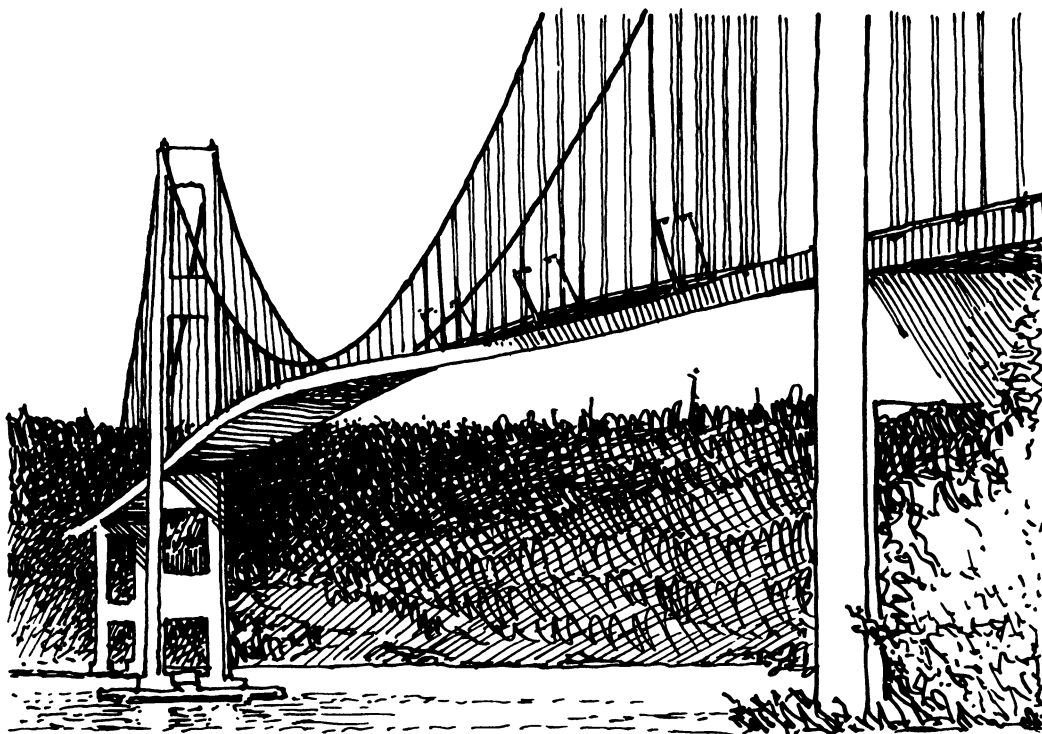
7.3 Twisting Motion of Tacoma Narrows Bridge

circular arc. Shortly before 10:00 A.M. Arkin again checked the wind velocity and saw that it had increased to 42 mph (67 km/h) and that the movement of the bridge deck had heightened dramatically; by his count, the deck rose and fell at the center of the bridge 38 times per minute with a 3 ft. (0.9 m) amplitude. Greatly concerned, Arkin halted all traffic, and Professor Farquharson, who happened to be at the site that day, observed that the up-and-down motion of the center span consisted of at least nine vertical undulations while the bridge was also deflecting laterally by as much as 2 ft. (60 cm). Suddenly the bridge started twisting violently, and the nine-wave motion changed to a two-wave motion while the bridge deck near the Tacoma side appeared to twist to an almost 45° angle (Fig. 7.3).

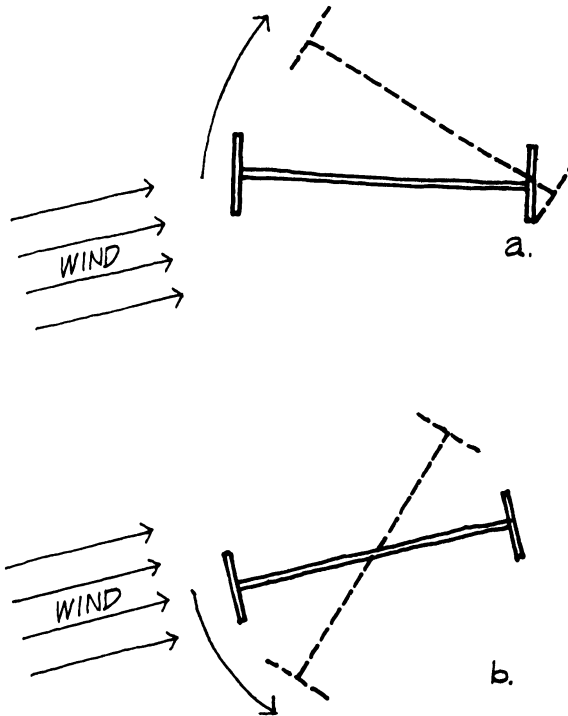
7.6 Wind-Induced Twist

* Recent (1991) studies suggest that the cause may be attributable to vortex shedding, a phenomenon first described by Theodor von Karman. Spiraling vortices can be seen in the wake of a ship moving through water, and similar, though invisible, vortices trail an airplane wing in flight. Two kinds of vortices were shed by the twisting Tacoma Narrows deck. The first is called a Karman vortex street because the periodic shedding creates a continuous pattern of alternating vortices. However, these vortices were out of sync with the natural frequency of the bridge and therefore could not contribute to a buildup of motion. The second was a flutterlike complex pattern of vortices with a frequency coincident with the bridge’s natural frequency that rapidly reinforced the destructive torsional oscillations. It is difficult to state whether the twisting oscillations of the deck caused these vortices or whether the vortices caused the deck oscillations, but at the present time this new assumption must be considered the best interpretation of the cause of the collapse.

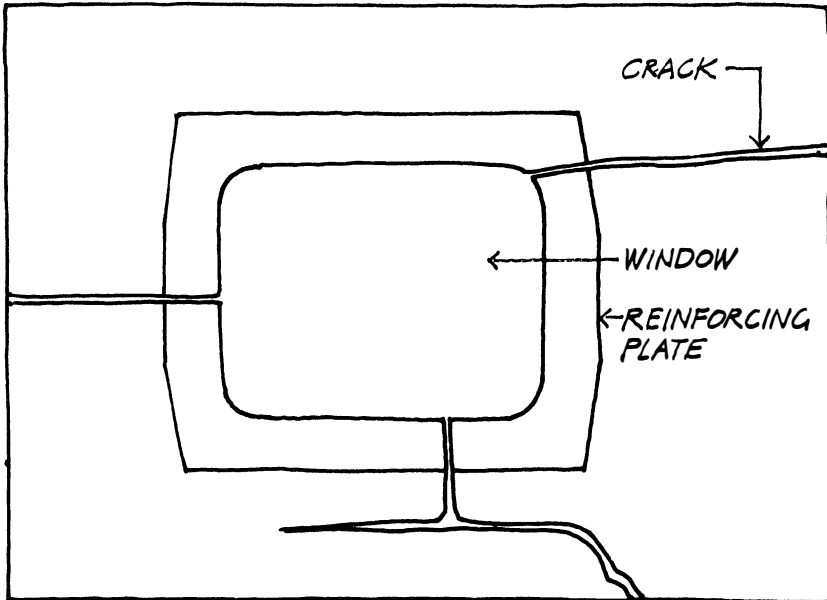
8.1b Cracks around Window

De Havilland had tested samples of the corner panel and an entire fuselage section of each plane, concluding that in terms of fatigue the cabins were good for a service life of about ten thousand flights or ten years. After the accident a test performed by the RAE showed failure after only three thousand cyclic load applications. This result, although only one-third of de Havilland's estimate of the fuselage's fatigue life, was still three times larger than the thousand-load applications experienced by the last two crashed Comets. Why this incompatible difference? Because, first, the de Havilland test did not accurately represent the actual cabin since complete windows were not fitted into the test section. Then there

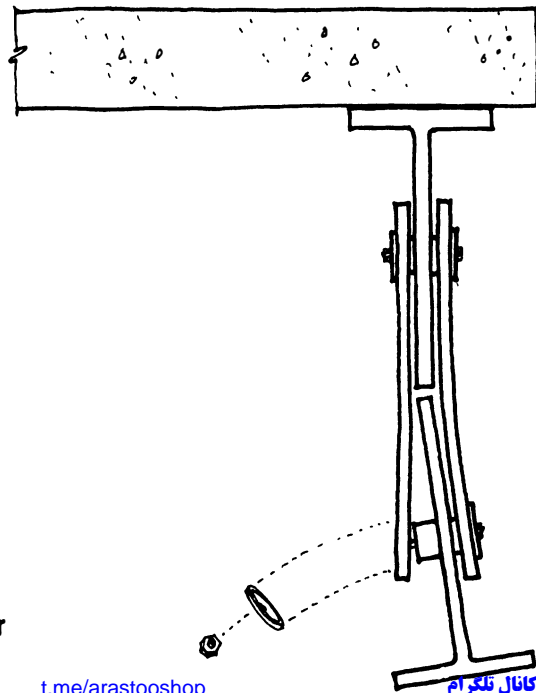
9.6 Failure of Hanger

We can now reconstruct the events leading to the collapse of the Mianus Bridge. Over the bridge's twenty-five years, corrosion builds up between the hanger plates and the pins because of the constant wetting action of rain, brought on by the paving over of the floor drains. Each time a car or truck passes over the bridge, the skew effect imposes a lateral force on the hanger plates, contributing to the tendency of the hanger plates to be pushed off the pin. At the southeast corner of the suspended span, the force of corrosion, aggravated by the skew effect, is so large that it causes the restraining pin cap to dish out and possibly pop off. Sometime before the collapse, hours or days earlier, the bottom of the inside hanger plate slips off the pin (Fig. 9.6), causing a transfer of the

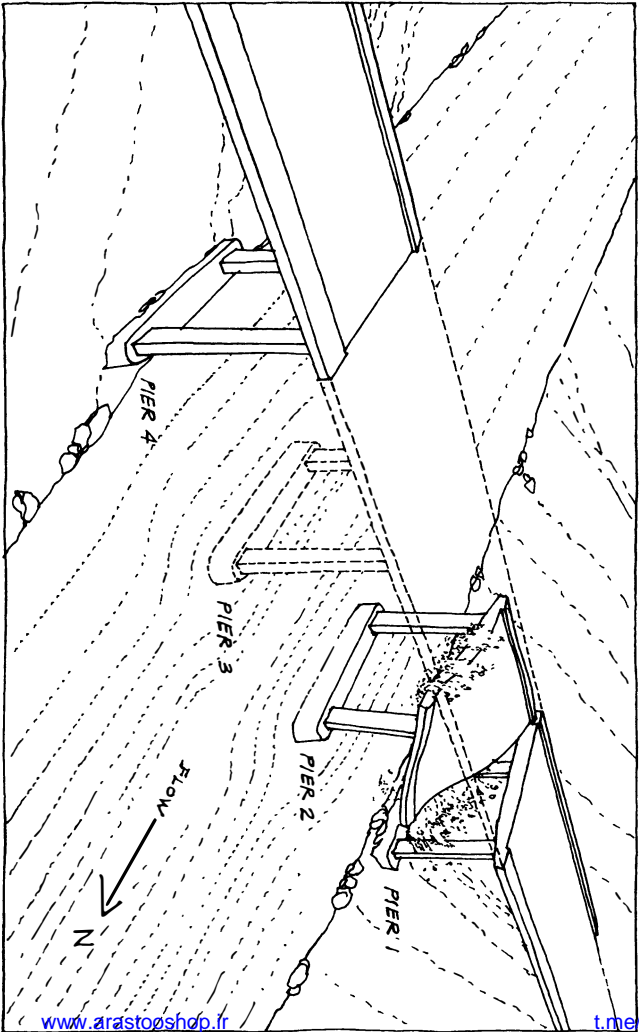
9.9 Collapsed Schoharie Bridge

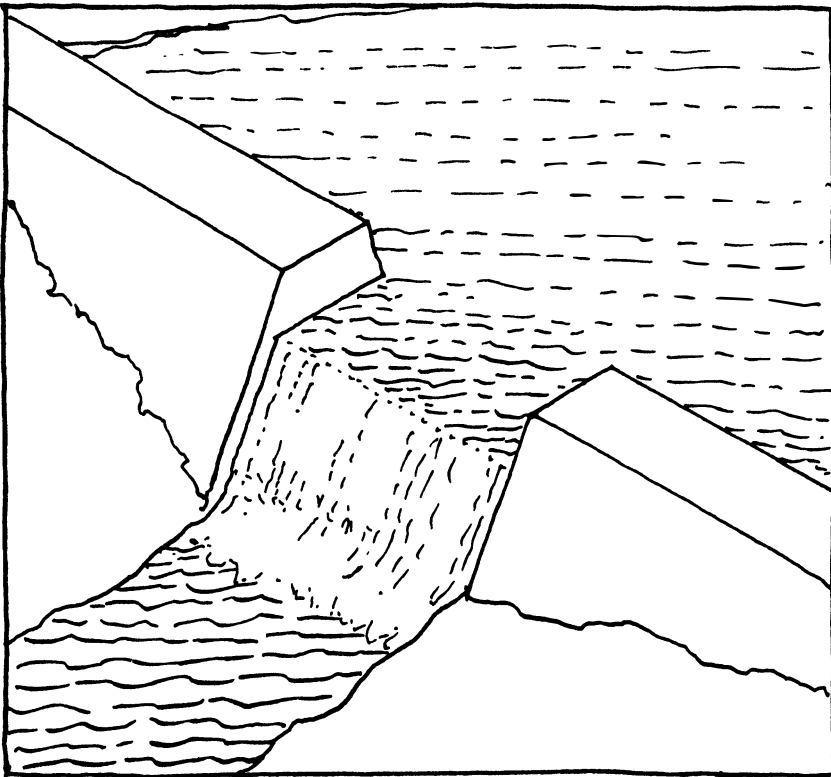
11.1 South Fork Dam: Original Construction

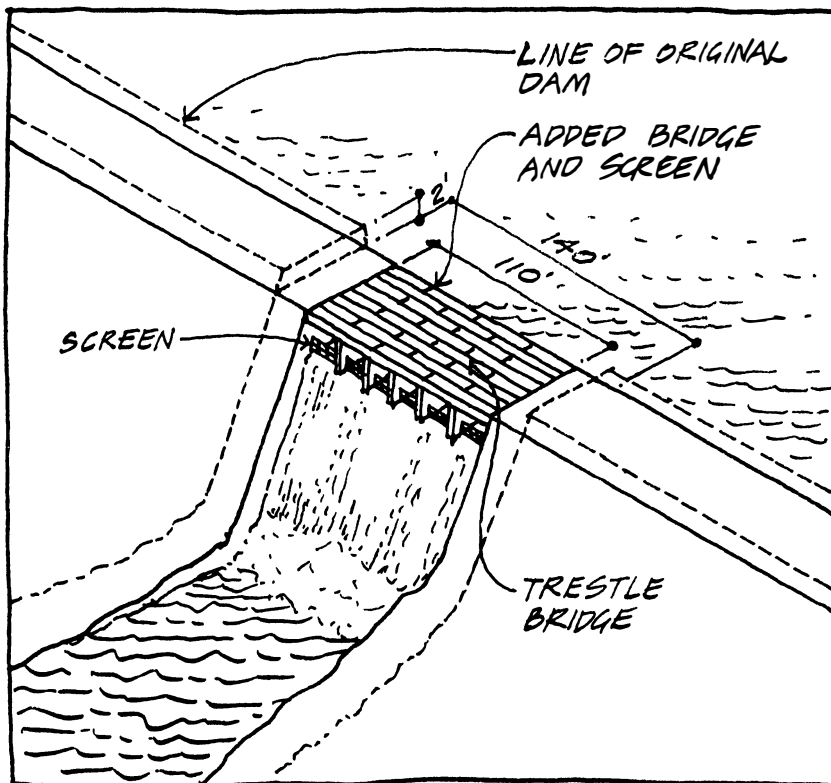
11.2 South Fork: Modified Dam and Spillway

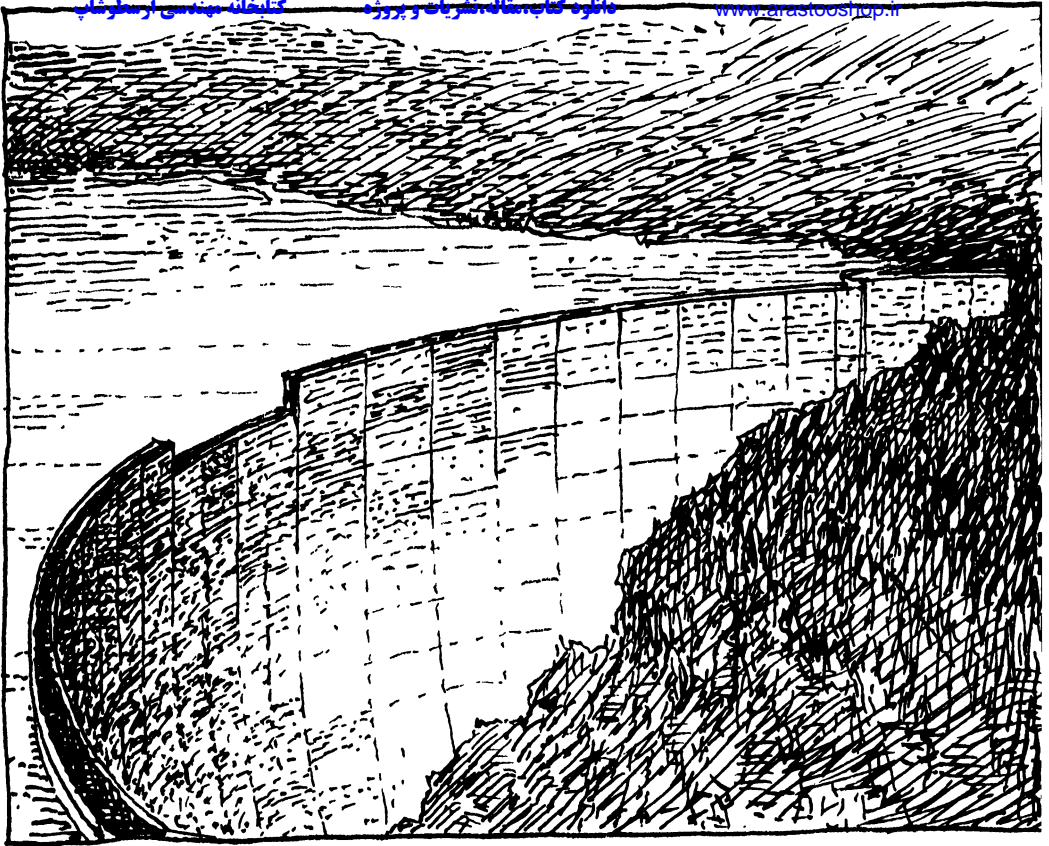
11.3 Malpasset Dam

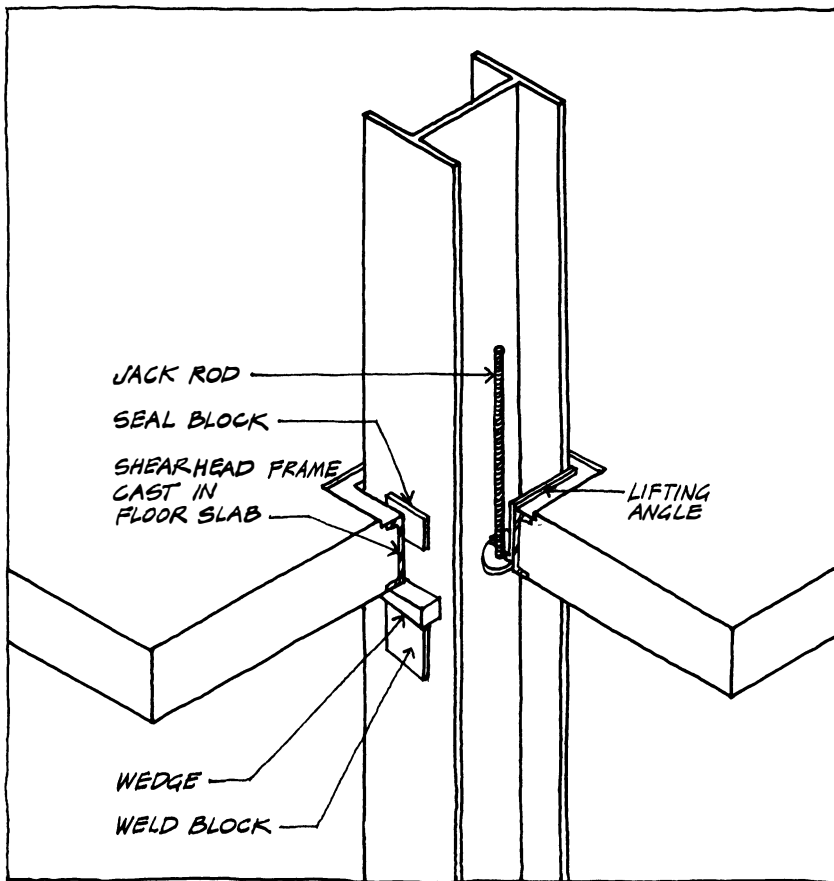
12.4 Typical Shearhead Arrangement

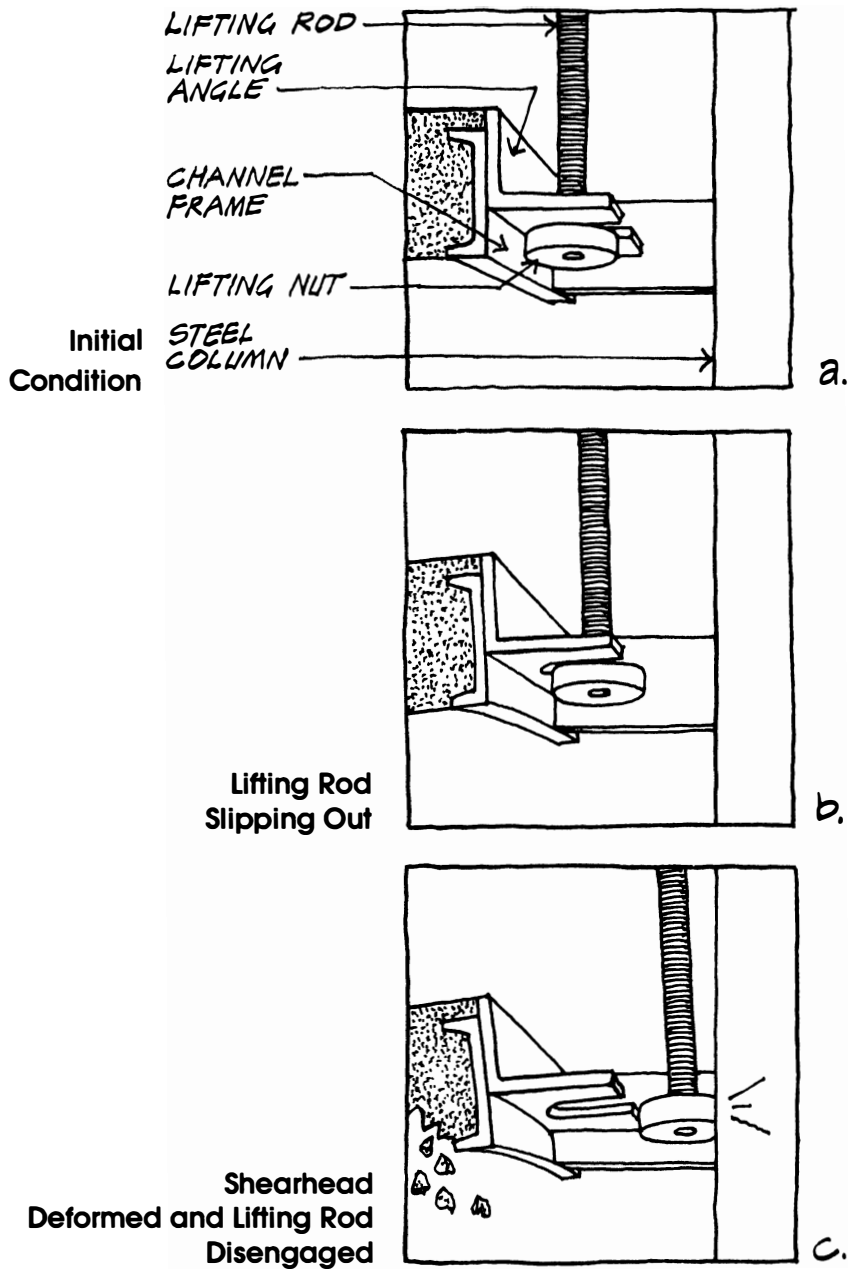
12.7 Failure Sequence

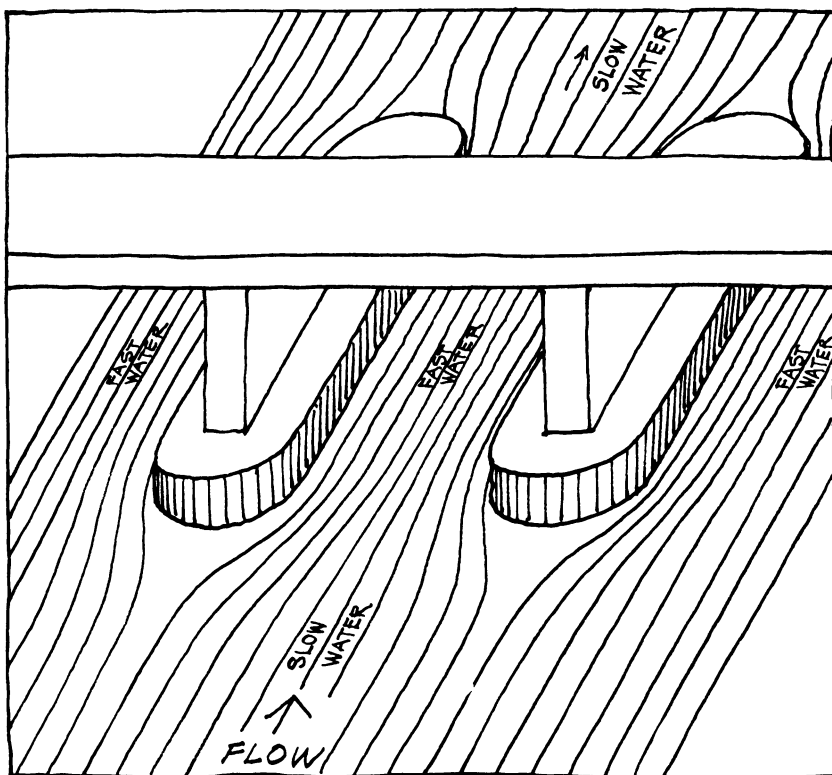
14.5 Flow of Water around Bridge Piers

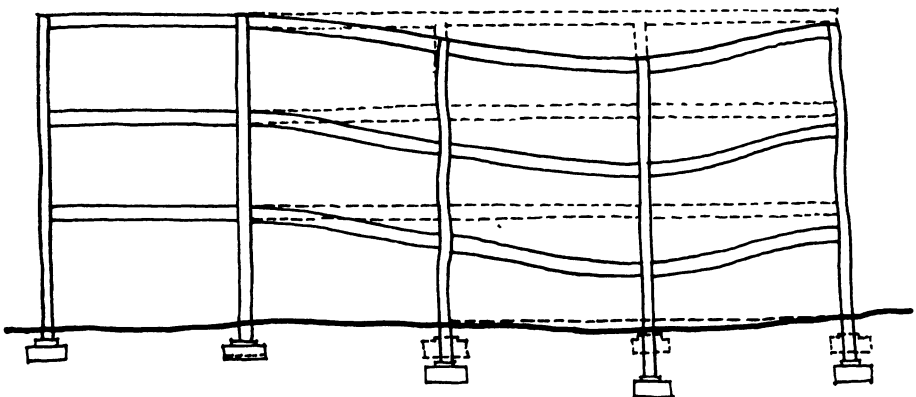
A4 Uneven Settlement of Building Foundation, Causing Bending of Beams

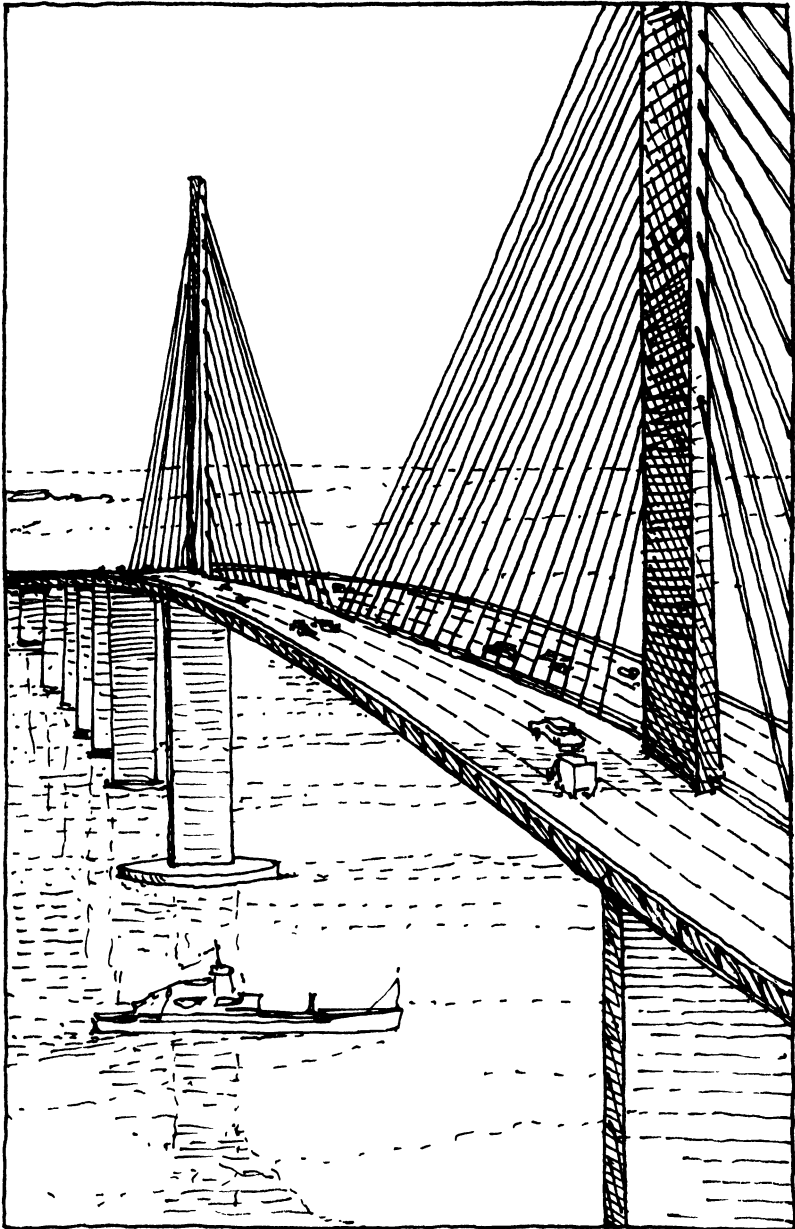
D37 Cable Stayed Bridge, Sunshine Skyway, South of St. Petersburg, Florida
